Dear Valued Blum Customer,

The Blum hinge and mounting plate you currently have are now discontinued/obsolete. Please refer to the illustrations below to determine the necessary modifications for your door and frame, based on the hinge and the style of mounting plate you currently have.

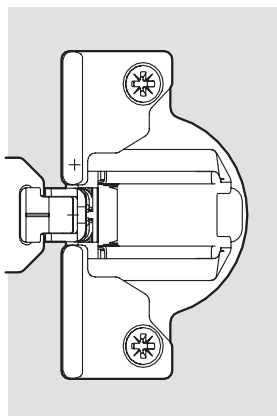
### COMPACT 31

**\*COMPACT 31 -**  
See steps below for  
**door side** replacement  
before page 2

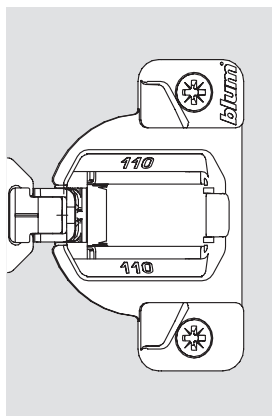
### COMPACT 33

**COMPACT 33 -**  
Skip the steps below and  
proceed to page 2

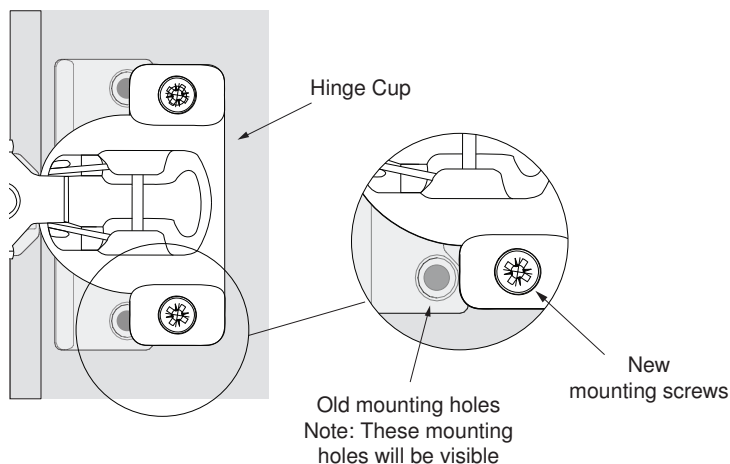
## COMPACT 31 replacement (door side)

When replacing a COMPACT 31, the direction of the hinge cup is rotated and the previous mounting holes will still be visible as shown below.

- For the hinge cup, you will need **#6 x 5/8 wood screws**

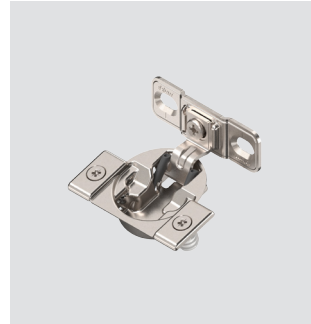
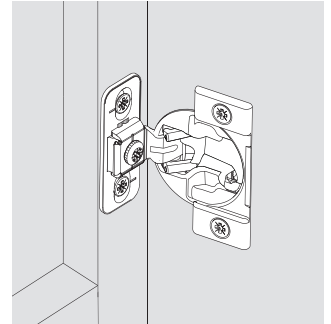
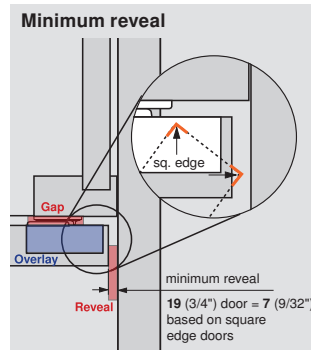
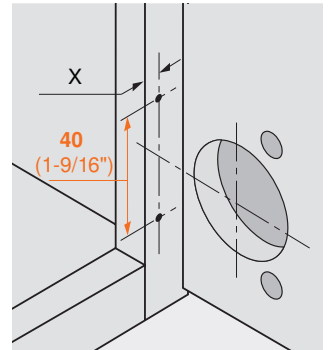
## Current replacement 38B

| Overlay (OL) | X |
| 41 (1-5/8") | 15 (19/32") |
| For any other overlays, use formula: $X = OL - 35 (1-3/8") + 9 (11/32")$ | |

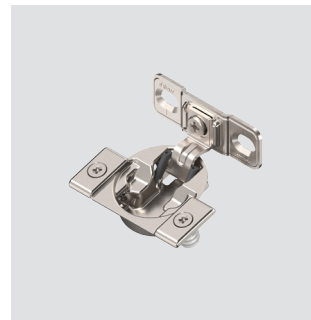
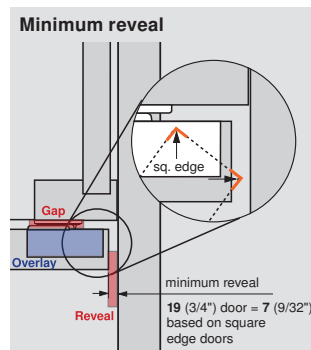
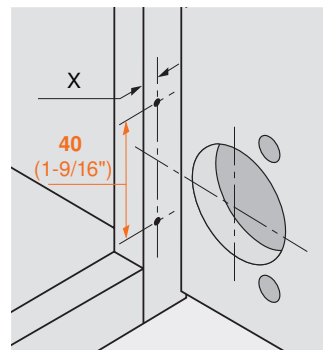
## Current replacement 38B

- Increase screw hole spacing to **40 (1-9/16")** on the new plate (previously **32 (1-1/4")**)
- Each screw hole shifts **4 (1/4")** outward from the cup hole centerline
